Worker Injured by Excavator

LEARNING FROM INCIDENTS

ACTION ALERT

HEALTH, SAFETY AND ENVIRONMENT SECTION
DEPARTMENT OF ADMINISTRATION AND FINANCE
PUBLIC WORKS DEPARTMENT

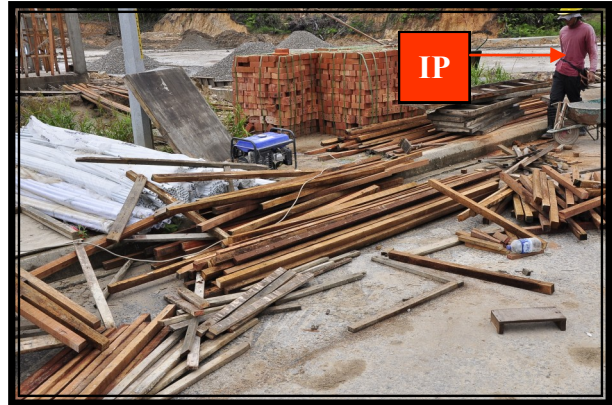
The incident happened on Wednesday, 27th March 2013 @ 16:05hrs at the Muara Tank Project Site, BSM Terminal. The project scope was to construct 2 new product storage tanks at Muara Terminal.

The IP, a 32 year old male was involved in the construction of a 1.0m high separator wall between the 2 tanks within the bunded area. A cement-filling activity was ongoing; IP's role was to operate the cement chute from a cement truck and to ensure that cement was properly poured into the excavator bucket. While the excavator to stand in a operator was filling in the separation bund wall with the concrete, the IP moved closer to the excavator to stand in a shaded area. The IP's back was to the excavator. As the excavator repositioned, it moved towards the IP and the excavator crawler track caught both of IP's legs. IP was taken to RIPAS hospital in Bandar Seri Begawan and was diagnosed as having fractured both feet and his left lower leg. IP underwent surgery.

- the project team did not address the tasks and associated risks (especially close man-machine interface) of using an excavator for concrete works
- There was no dedicated signalman appointed and no established communication protocol, and
- Lapse of concentration by the driver & IP

- MOC process was not initiated to address change to construction method from crane to excavator use
- Inadequate numbers of Work Site Supervisor (WSS) at critical stage, no continuous presence of WSS
- Signalman role is not recognized and assessed as HSE critical position
- Fatigue from extensive working hours (0630hr to 2200hr). Culture of working long hours in construction industry in Brunei
- No recorded testing of project Medical Emergency Response (MER).

- Apply MOC process to formalize all changes to the approved construction method statements and HIPs
- Need to improve knowledge of the hazards of moving heavy equipment and necessary mitigation measures among project teams by undertaking following recommendations :

1. undertake a specific TBT to address risks associated with moving heavy machinery on site
 2. Incorporate heavy machinery movement risks in regular TBTs and strengthen in the site induction pack.

3. Improve machinery / pedestrian segregation on site to avoid unauthorized access (e.g. via hard barriers)
- Ensure continuous presence of WSS if defined in the permit to work, deputy WSS MUST be formally appointed to each work site where continuous presence is required.

- Establish the role of signalman with respect to operation of mobile mechanical plant on construction site.
- Establish and enforce communication protocol between plant operator and signalman.

- Review the days and hours of work of the construction crew against the Brunei Labour Law. Ensure adequate rest is being given to / taken by the crew.

- MER drills to be conducted on a regular basis to test readiness of team and sharpen response times.
